**Final Report of a Pilot Project on the**  
**West Branch of Jones Run,**  
**Mill Creek Watershed, Clarion County:**  
**Stream Application of Code 60 Limestone Fines**  
**Into an AMD Affected Stream**

**The Mill Creek Coalition of Clarion & Jefferson Counties (MCC)**

**FINAL REPORT OF A PILOT PROJECT ON THE WEST BRANCH OF JONES RUN,  
MILL CREEK WATERSHED, CLARION COUNTY:  
APPLICATION OF CODE 60 LIMESTONE FINES  
December 2019**

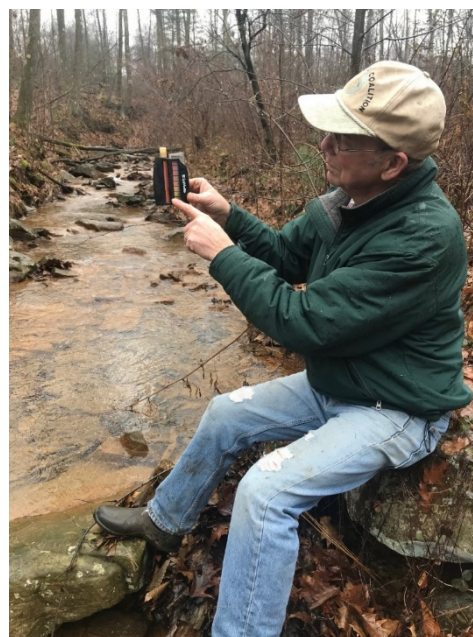
**Figure 4. Photo was taken looking upstream, at the approximate location from which the macrobenthic samples were collected, showing the riffle-pool feature along most of its length. Photo by Jen Moore.**

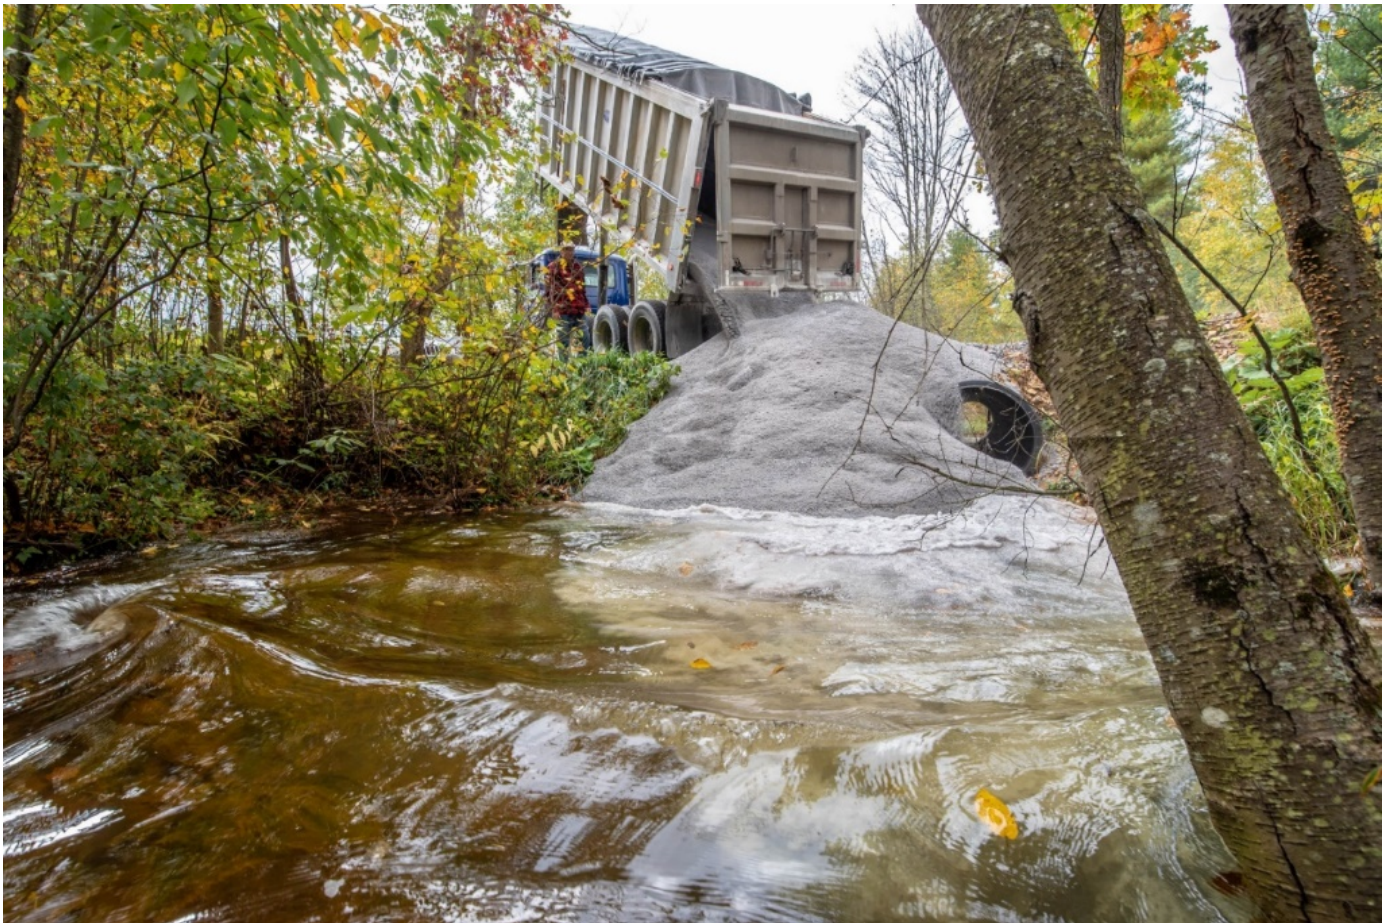
**Figure 5. The last load arrived on October 12. It was the inaugural first load directly placed into the West Branch of Jones culvert pool. Photo by Brett Whitling, Clarion News.**

With the final \$2,000 grant attained in late September, the trucking contract was awarded to Confer Trucking, Inc. located near Bellefonte. The first triaxle load was delivered to the stockpile facility on October 3, followed by 7 more loads, totaling 181 tons with the last load dumped directly into the West Branch of Jones Run on October 12, being the inaugural load (Figure 5).
