# Leisure Run

## *Watershed Assessment and Conservation Plan 2023*

# Leisure Run Watershed Assessment

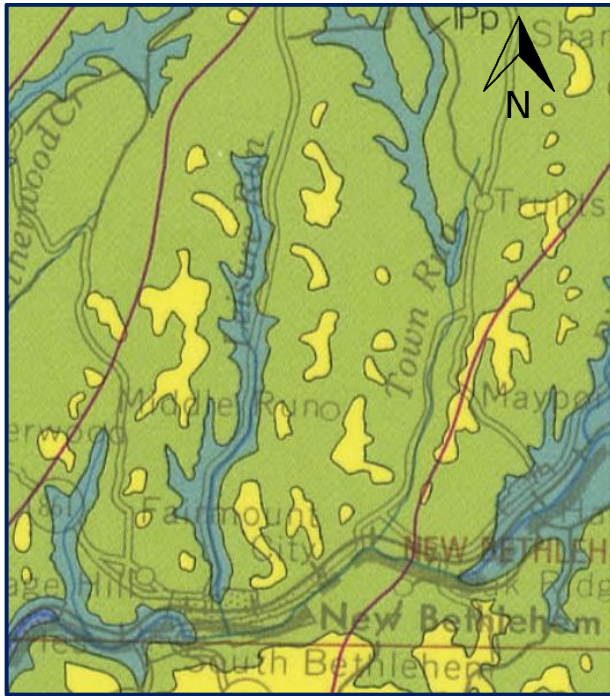
Fig. 2. USGS map of the Glenshaw, Allegheny, and Pottsville formations (USGS).

The watershed resides entirely on the Allegheny Plateau and has not been influenced by the Laurentide ice sheet. Geology is composed of Glenshaw, Allegheny, and Pottsville groups dominated by shale, sandstone, limestone, and coal layers (Fig. 2). Notably, the study area is underlain by the Vanport Limestone carbonate bedrock layer along its margins, as discussed later in this report.

- IPcg**    **GLENSHAW FORMATION**  
 Cyclic sequences of shale, sandstone, red beds, and thin limestone and coal; includes four marine limestone or shale horizons; red beds are involved in landslides; base is at top of Upper Freeport coal.

- IPa**    **ALLEGHENY GROUP**  
 Cyclic sequences of sandstone, shale, limestone, clay, and coal; includes valuable clay deposits and Vanport Limestone; commercially valuable Freeport, Kittanning, and Brookville-Clarion coals present; base is at bottom of Brookville-Clarion coal.

- IPp**    **POTTSVILLE GROUP**  
 Predominantly gray sandstone and conglomerate; also contains thin beds of shale, claystone, limestone, and coal; includes Olean and Sharon conglomerates of northwestern Pennsylvania; thin marine limestones present in Beaver, Lawrence, and Mercer Counties; minable coals and commercially valuable high-alumina clays present locally.

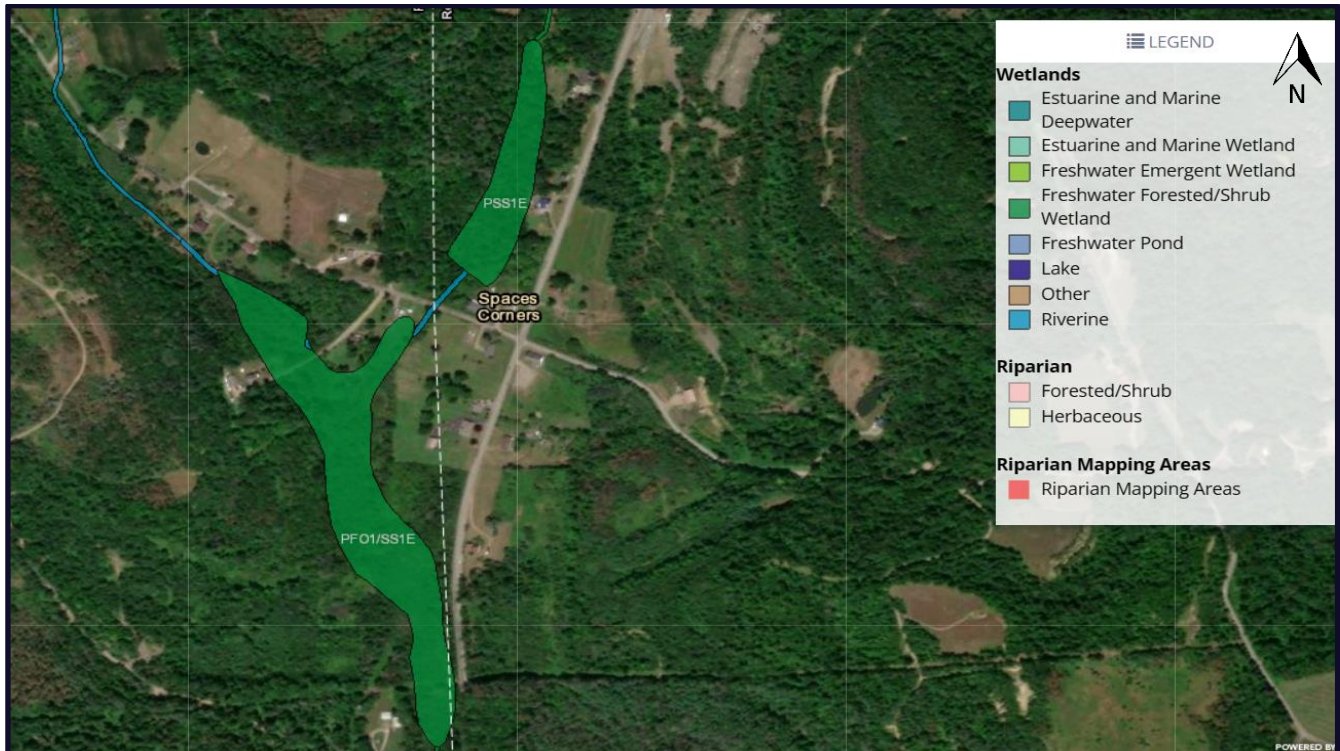
Fig. 4. Wetland map of Leisure Run at Swartfager Road (US Geological Survey).

There are only two delineated wetlands within the Leisure Run watershed as provided by the National Wetlands Inventory. Both of these wetlands are in the area of Swartfager Road and are palustrine Freshwater Forested/Shrub wetlands (Fig. 4).

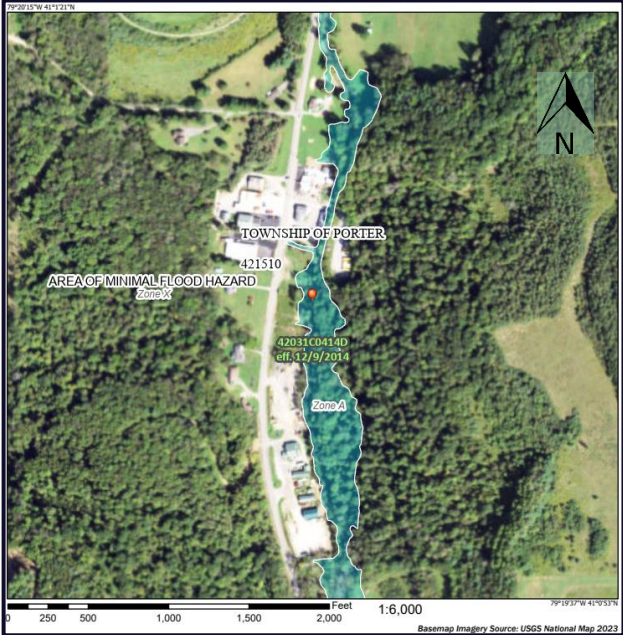
Fig. 5A. Floodway map area of concern on upper mid-reach of Leisure Run (eMapPA).

Historical flooding in the Leisure Run watershed has been a persistent concern with more recent major flooding events occurring in 1996 and 2019. As discussed earlier, the combination of soils with low infiltration rates and severely degraded riparian buffers, leave this watershed vulnerable to flash flooding events (Fig. 5A-C). This concern has led to landowners taking drastic measures such as dredging the stream bed to construct earthen berms in an effort to protect their properties located within the designated floodway. Formation of a private watershed organization, in cooperation with the conservation district, could greatly enhance awareness and develop potential solutions to these persistent watershed issues.

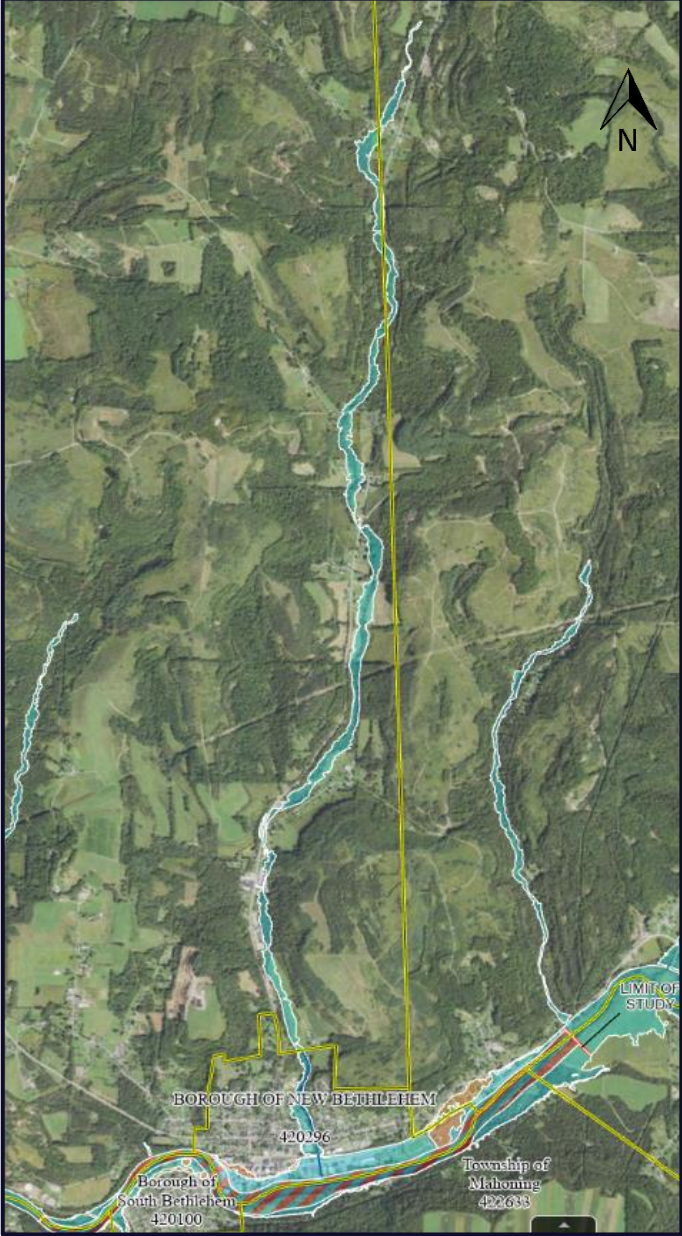
Fig. 5C. Floodway map of the Leisure Run watershed. The floodway encompassing FEMA Flood Zone A and AE is depicted in light blue (eMapPA).

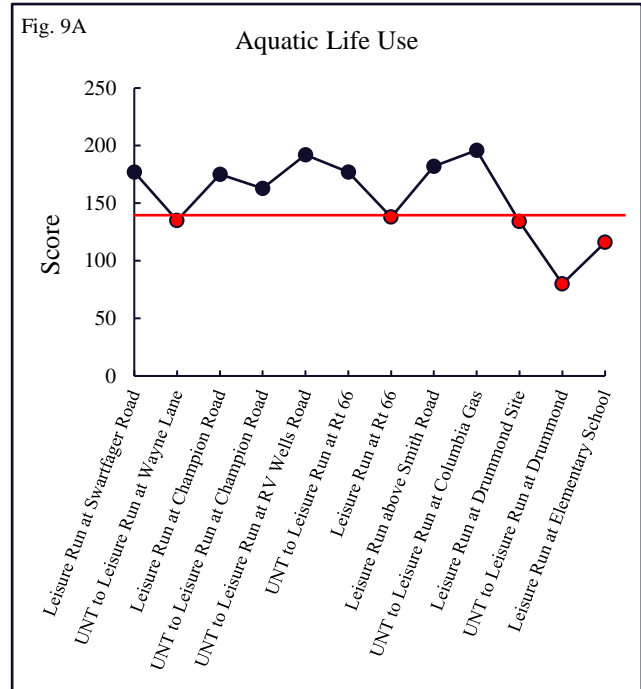
Five (5) of the twelve (12) sites evaluated during this assessment indicate habitat impairment that would inhibit ALU (Fig 9A). Three of those are marginally impaired while the remaining two are significantly impaired. The primary causal factors for the impairment are the lack of instream cover for aquatic organisms to utilize; lack of varied velocity/depth regimes that provide habitat for diverse species; stream embeddedness; and unstable or eroding stream banks.

Fig. 9A. Total ALU score out of a possible score of 240. The red line indicates the minimum ALU score necessary (140) to support ecological integrity and ensure ALU. Data is arranged from upstream to downstream.

Leisure Run has a stable and abundant assemblage of fishes as documented in this report, but the need for in-stream habitat improvements and streambanks stabilization was evident at almost all sampling locations. In-stream habitat improvements should be prioritized based on the findings of the habitat surveys documented in this report.

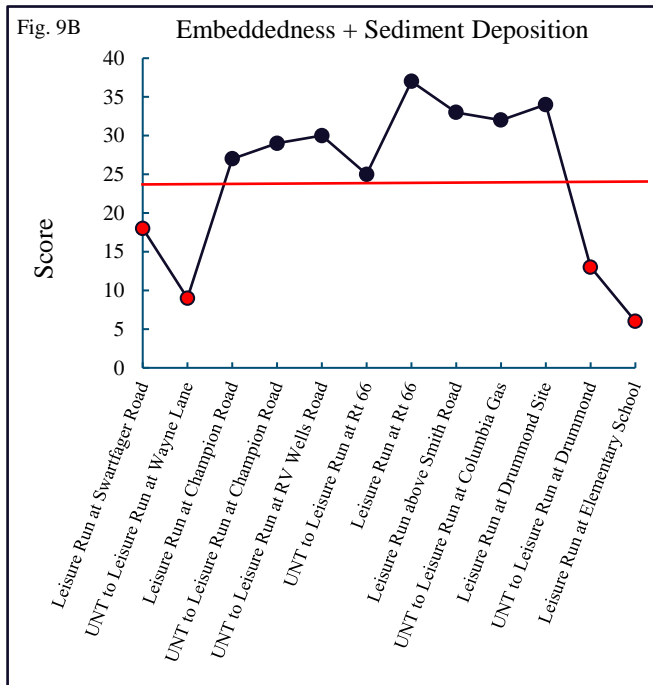
Four of the twelve habitat parameters in the PA DEP protocol are strong predictors of habitat degradation leading to ALU impairment and when paired together can act as stand-alone parameters for assessment decisions. The impairment threshold for the parameters of embeddedness + sediment deposition, or condition of banks + bank vegetative protection is a total score of 24 or less out of a possible 40 points. Of the sites evaluated in the Leisure Run watershed, 6 of the 12 sites indicate habitat impairment that would inhibit ALU with the primary causal factors being sedimentation and streambank erosion; particularly in the lower reaches of the watershed (Fig 9B and 9C). Comprehensive habitat data is available at Appendix B.

Fig. 9B. Paired stand-alone predictors of embeddedness and sediment deposition. When paired together with a score of 24 or less out of a possible 40, indicates impaired habitat for ALU. Data is arranged from upstream to downstream.

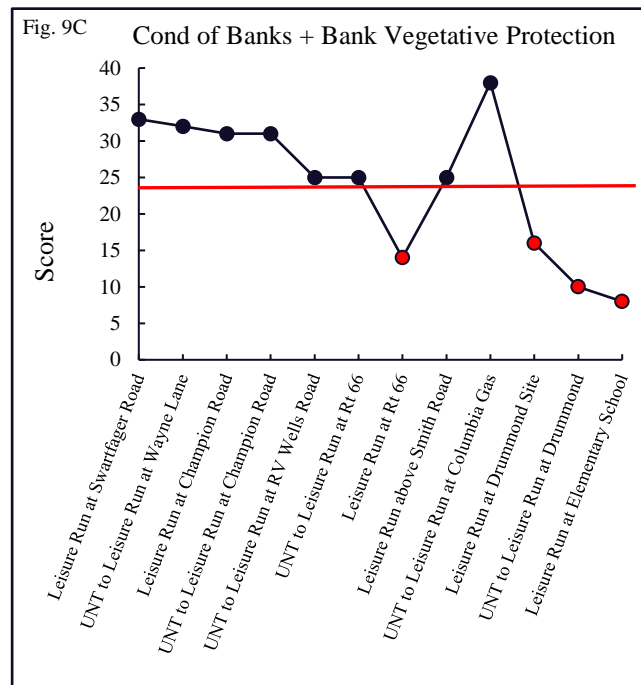
Fig. 9C. Paired stand-alone predictors of condition of streambanks and streambank vegetative protection. When paired together with a score of 24 or less out of a possible 40, indicates impaired habitat for ALU. Data is arranged from upstream to downstream.

Restoration of riparian buffers throughout the watershed should be a high management priority. Restoring vegetated riparian buffers is the most impactful management action that can occur. While preferred to maintain a 50-150 foot riparian buffer, this may not be practical for all landowners in the watershed. This should not deter landowners and land managers from restoring what areas they can; even if only 5 to 10 feet from the stream bank. Any enhancement to the buffer will mitigate surface water runoff; provide increased water infiltration into the soil and filtering of pollutants; and lessen erosion of streambanks and stream channels. Perhaps the greatest value in slowing surface water runoff is the potential this has for mitigating flash flood events. There are many programs and grants available that would provide this service free of cost to the landowners.
