# Canoe Creek

## *Watershed Assessment and Conservation Plan*

### 2026

**Authored by:** Kylie Shaw, Watershed Specialist  
Clarion Conservation District  
249 S. 2nd Avenue  
Clarion, PA 16214

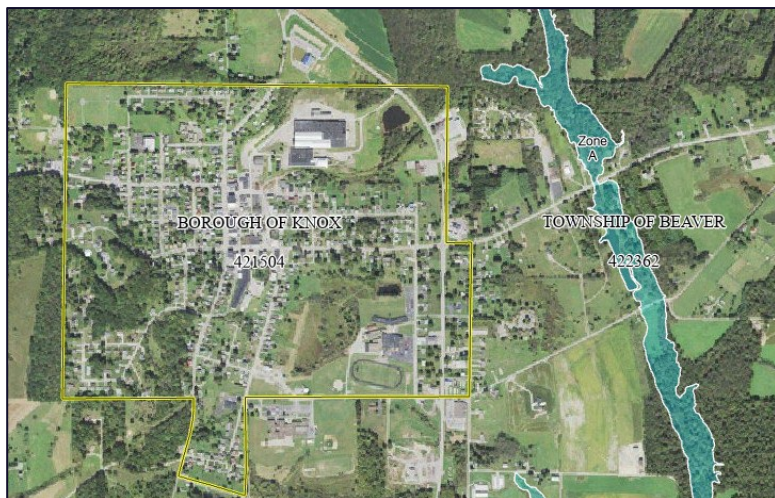
Fig. 6A. Floodway map near Borough of Knox (FEMA).

According to the FEMA floodway maps, there are no floodways within the Borough of Knox, the area of highest population density within the Canoe Creek watershed (Figure 6A). The floodway of Canoe Creek and one of its tributaries do run under Interstate 80 (Figure 6B). The I-80 bridge that crosses Canoe Creek is currently under construction and the impact of floodway on the bridge should be reevaluated after construction is complete.

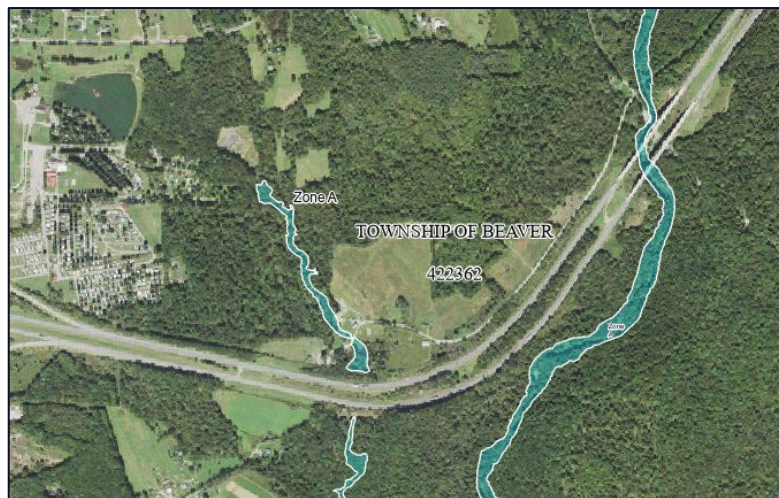
Fig. 6B. Floodway map area under Interstate 80 (FEMA).
