Assessment of AMD Discharges in the Downstream Section of Little Mill Creek, Clarion County, PA

**This Document is Based on a January 25, 2016, Technical Report
Provided by Hedin Environmental for Headwaters Charitable Trust
Trout Unlimited AMD Technical Assistance Program**

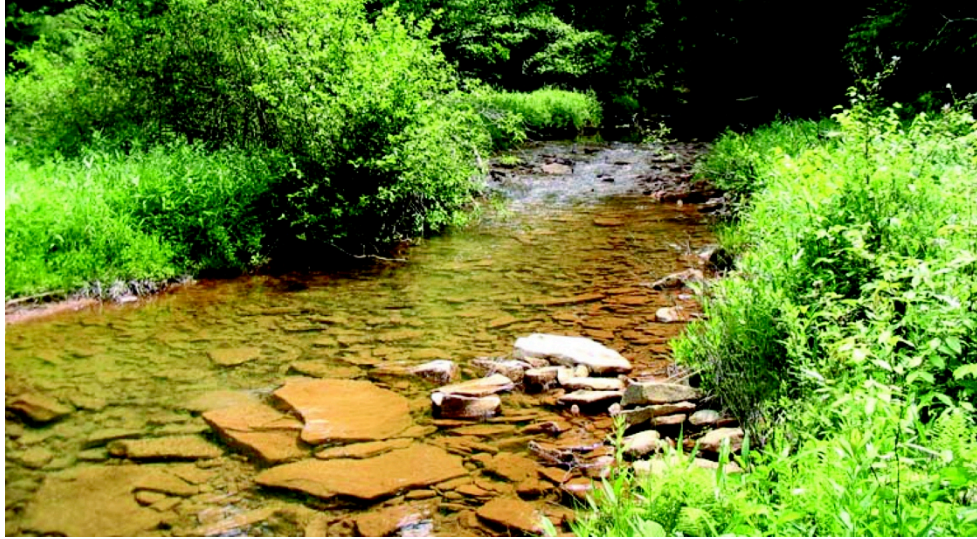
Figure 2. Little Mill above the Markle/Kotchey treatment system. Iron levels are about 0.5-1.0 mg/l and the pH is about 7.0.

The Markle/Kotchey and Asbury Road tributary flows have a dramatic visual effect on Little Mill as well as affecting Little Mill's water chemistry (Figures 2, 3).

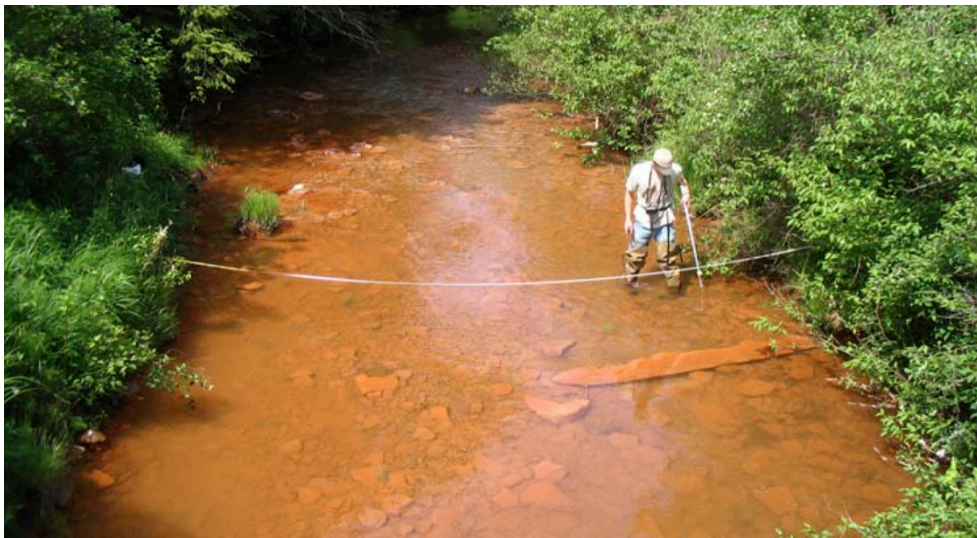
Figure 3. Little Mill below the treatment system discharge (looking downstream from the Asbury Rd. Bridge). The 60-80 mg/l of iron from the Markle/Kotchey site is diluted by Little Mill to 7-10 mg/l of iron and the pH has dropped to about 6.5.

In addition, a significant amount of the iron leaving the treatment system is in a particulate form, thus suspended in the stream or coating the substrate. The iron coating as well as the iron turbidity decrease rather markedly as the stream flows the 2.5 miles toward Mill Creek. By the time Little Mill reaches Mill Creek, the iron has dropped several mg/l and the pH is near 6.0 (Table 2).

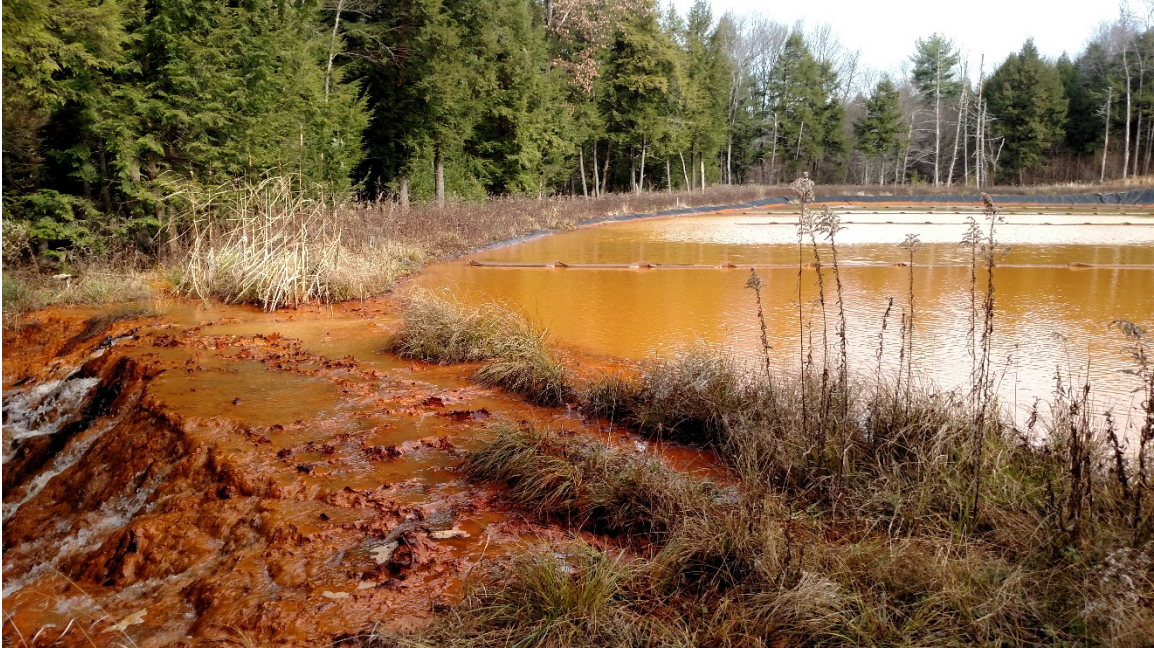
Figure 4. A clogged discharge pipe at the Markle/Kotchey treatment system causes the settling pond to discharge over the berm. Accumulated iron solids suggest the pond has been discharging in this manner for a long time.

The Markle/Kotchey treatment system is the largest source of acidity (about 50%) and iron (about 80%) to this lower segment of Little Mill Creek and should be the primary focus of future restoration efforts. TU conducted an AMD technical assistance project on the site in 2007. The primary treatment problems at that time were that the settling pond was too small for the iron loadings and the ALD did not generate enough alkalinity to yield a net alkaline discharge. The November 2015 site visit discovered additional problems. A clogged effluent pipe has resulted in water overtopping the berm and the presence of water underneath the liner (Figure 4). The raised water level causes other issues such as ineffective baffles and difficulty in measuring the total flow into the stream.
